AIRTuB: towards automated inspection of leading edge erosion of wind turbine blades by shape analysis

Andrei G. Anisimov^{*a}, Ronald Beukema^b, Jason Hwang^b, Rogier Nijssen^c, Roger M. Groves^a

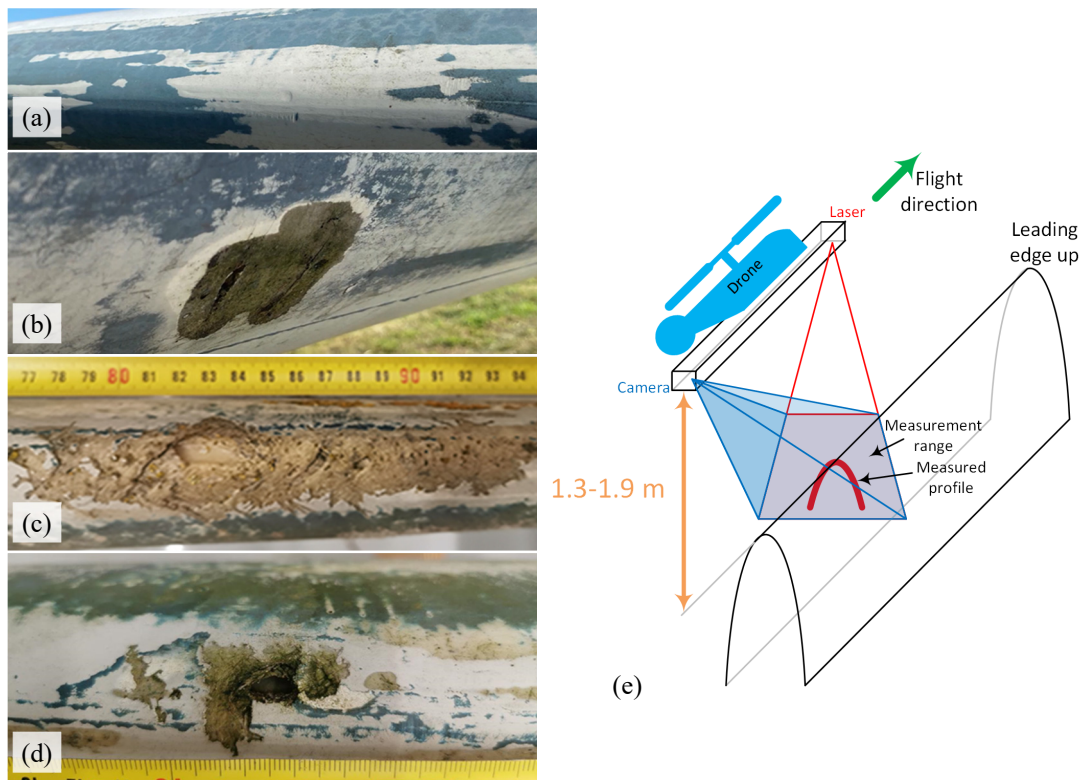
In this project, a customized long-range laser line scanner is used to measure the profiles of the blades to quantitative characterize the erosion and other damage cases (Figure 1 (a-d)). This sensor choice was made based on a detailed comparison of the optical shape measurement techniques and their applicability to drone-based inspection [6]. The laser line scanner is a rational compromise when the drone-related issues are taken into account (e.g. vibrations, mass and power budgets) together with the real outdoor and offshore conditions (e.g. sunlight, salt-forming on blades). During measurements (Figure 1 (e)), a drone will carry the laser line scanner over the leading edge of the blade. The blade will be oriented with the leading edge up to arrange a reasonable clearance distance of 1.5-2 m which was identified as a safe clearance between the drone and the blade. This distance range is predicted to be safe for a large drone even in case of a wind gust or a subsystem failure.

Figure 1. Real-life damage cases of a wind turbine leading edge, including (a) erosion, (b) loss of coating, (c) severe erosion, (d) probable impact or lightning damage. (e) presents the proposing drone-based measurement approach with the laser line scanner.

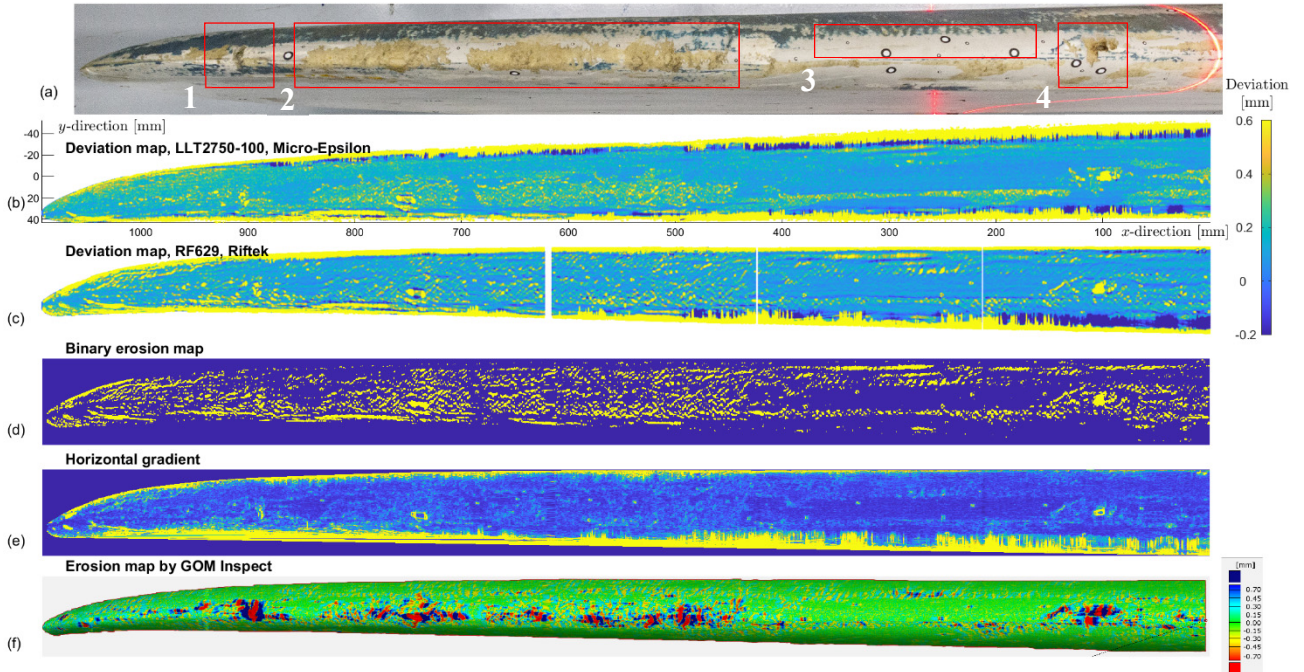
The tip segment of the blade that was used for this project has multiple defects, including severe damage in areas 1 and 4 (Figure 3 (a), also shown in Figure 1 (c,d)), a moderate erosion in area 2 and a healthy reference area 3. The shape of this tip segment was measured with two laser line scanners, the results for the first 1.1 m part of the blade are presented and analysed in this paper.

First, the reference deviation map was processed from the shape data obtained with the LLT2750-100 scanner by Micro-Epsilon (Figure 3 (b)). All areas of interest 1-4 can be reliably identified in the deviation map and further processed. The overall height range where the features are reliably seen is about 0.8 mm.

Second, the deviation map with the RF629 scanner by Riftek (Figure 3 (c)) was obtained. The severe damage areas 1 and 4 are also reliably identified, however, the boundaries of the moderate erosion area 2 are less clear. This directly affects the clarity of the binary defect map (Figure 3 (d)) with the global threshold of the height deviation set to 0.2 mm.

The healthy area 3 is clearly seen in the deviation maps from both sensors (Figure 3 (b-c)), also in the binary map (Figure 3 (d)). This fact defines an alternative approach to detect erosion: tracking of the healthy areas first and further evaluation of the deviating areas.

Figure 3. Overview of the experimental results (a) with the tip section of the blade, (b) the deviation map based on the shape measured with the LLT2750-100 scanner by Micro-Epsilon, (c) the deviation map based on the shape measured with the RF629 scanner by Riftek. The deviation map (c) was further processed to give (d) the binary erosion map and (e) the horizontal map gradient, and (f) the surface defect map based on the shape measured with the RF629 scanner processed by the GOM Inspect software.

The severe damage areas 1 and 4 scatter back a limited amount of the laser light and cause issues with the defect contouring. The image derivative in the horizontal direction (Figure 3 (e)) was identified to provide reliable contouring in addition to the binary map (Figure 3 (d)).

fitting a 3D smooth surface into the pointcloud and calculating the deviation, which is a proprietary algorithm. The calculated erosion map shows a clear identification of the areas 1 and 4, also the area 2 with moderate erosion.

Comparison of the individual profile processing (Figure 3 (c-e)) and the full 3D fitting (Figure 3 (f)) shows that the 3D fitting is more reliable in the upper and lower sides of the blade where the surface curvature is significant. Processing of the individual lines shows reliable deviation maps close to the center of the leading edge, while at the top and bottom sides (Figure 3 (c-e)) the individual fitting is less reliable.
