# Internal damage detection in wind turbine blades using an autonomous Aerial Radiography System

A digital radiography system integrated on synchronized UAV's for internal damage detection

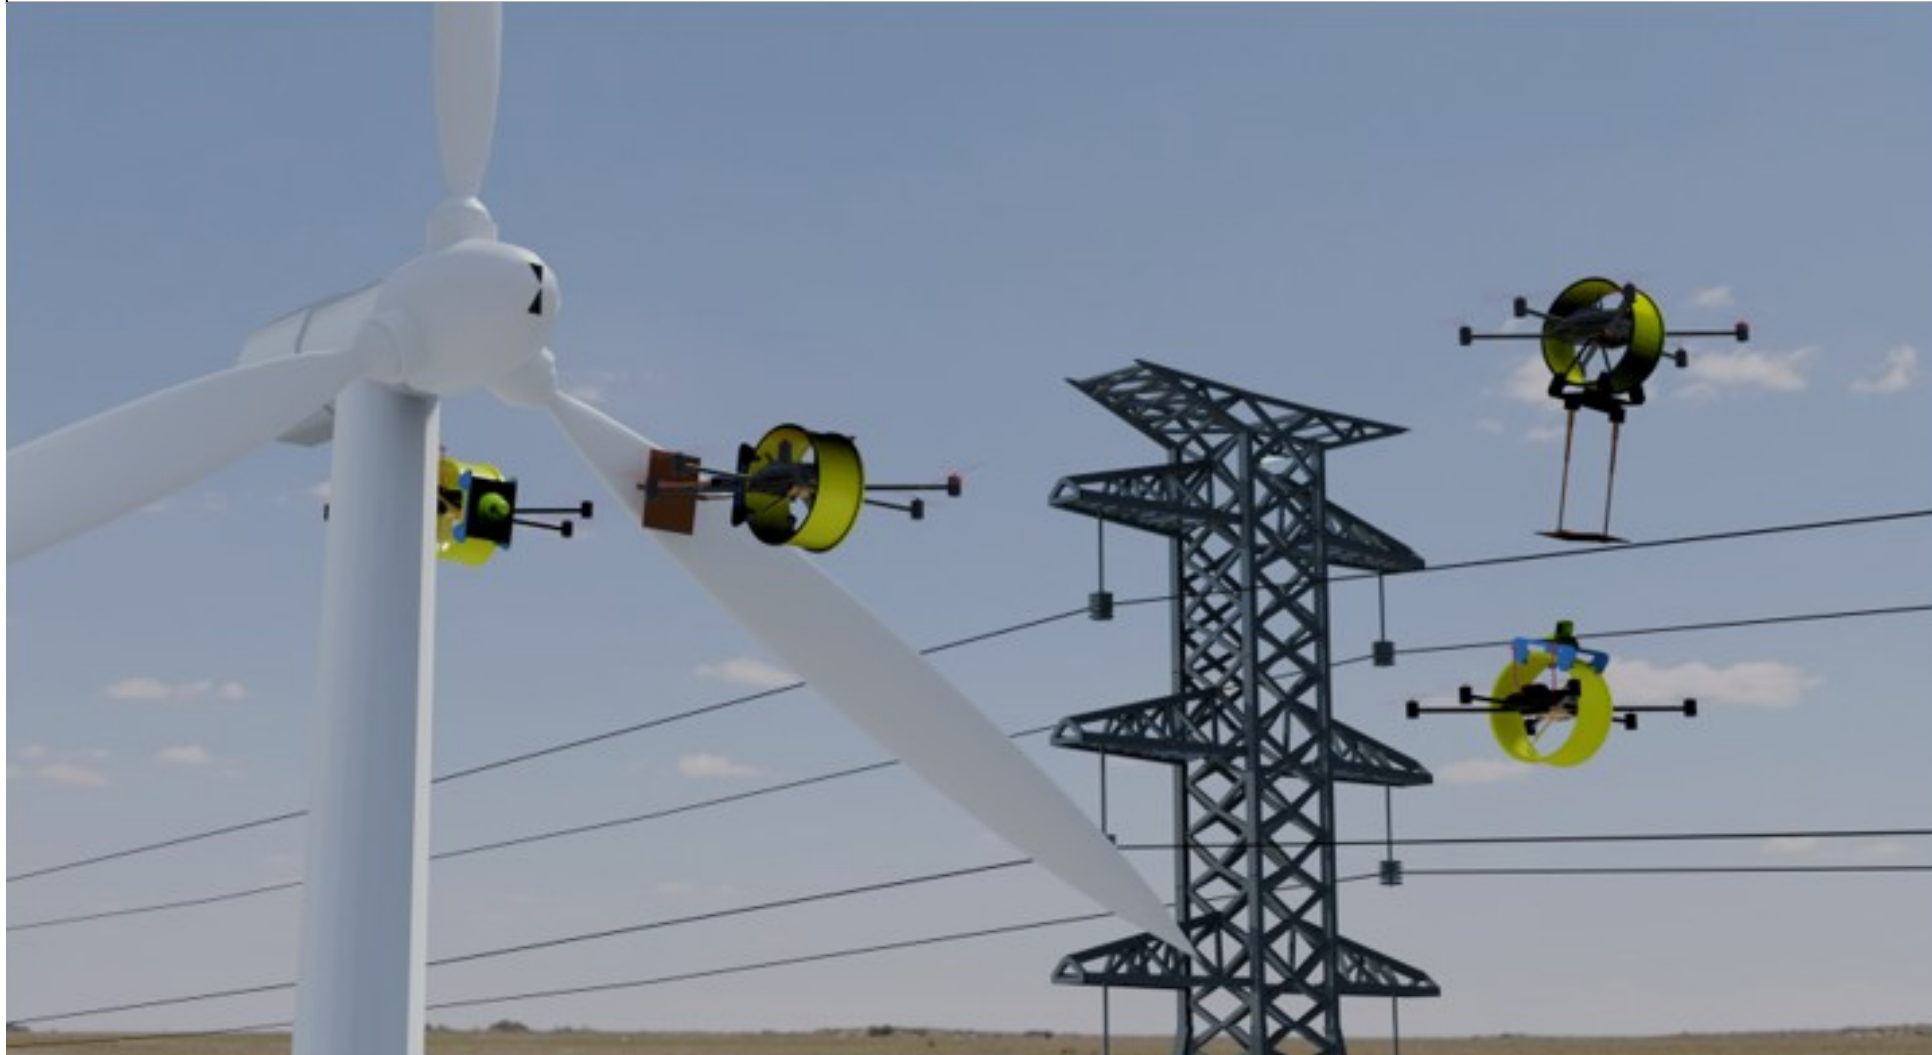
- Complete integrated system designed to detect structural internal defects such as delamination, debonding and cracks.
- The solution is built on the pillars of 4 technologies:
  1. Aerial positioning & synchronization
  2. Active control system / Robotic motion compensator
  3. Radiography control
  4. Image enhancement & processing

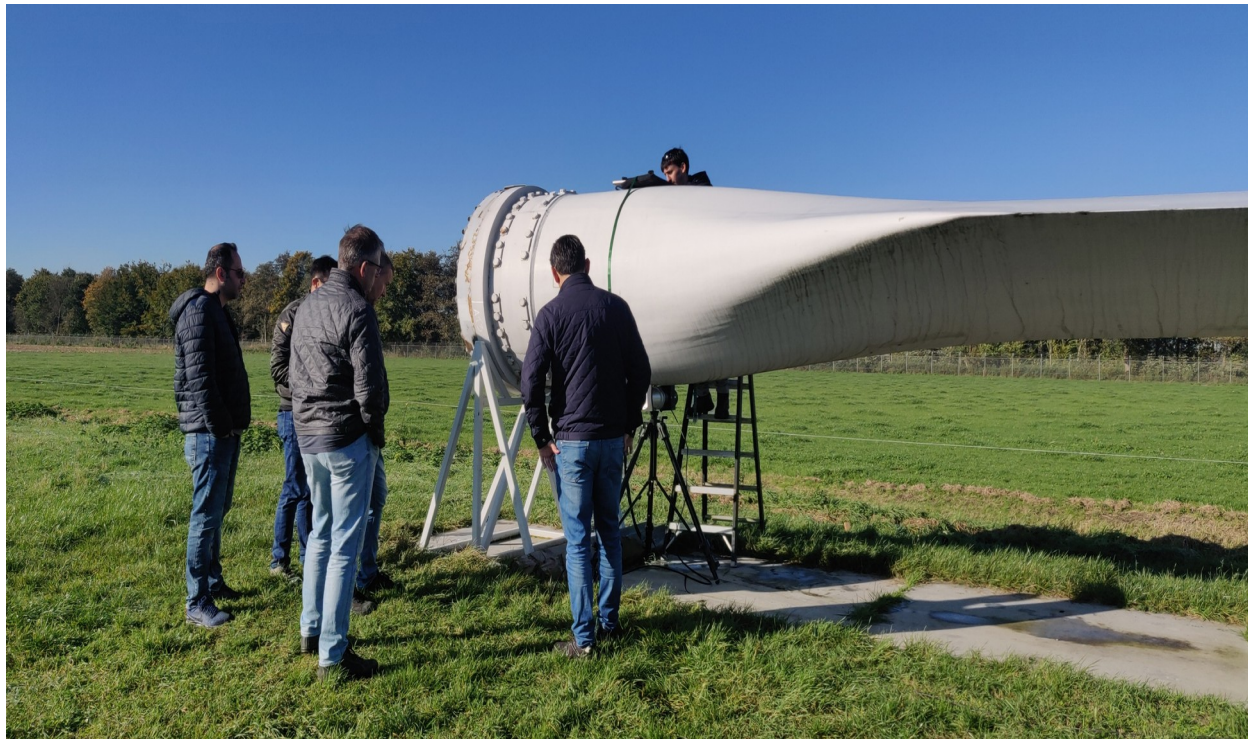
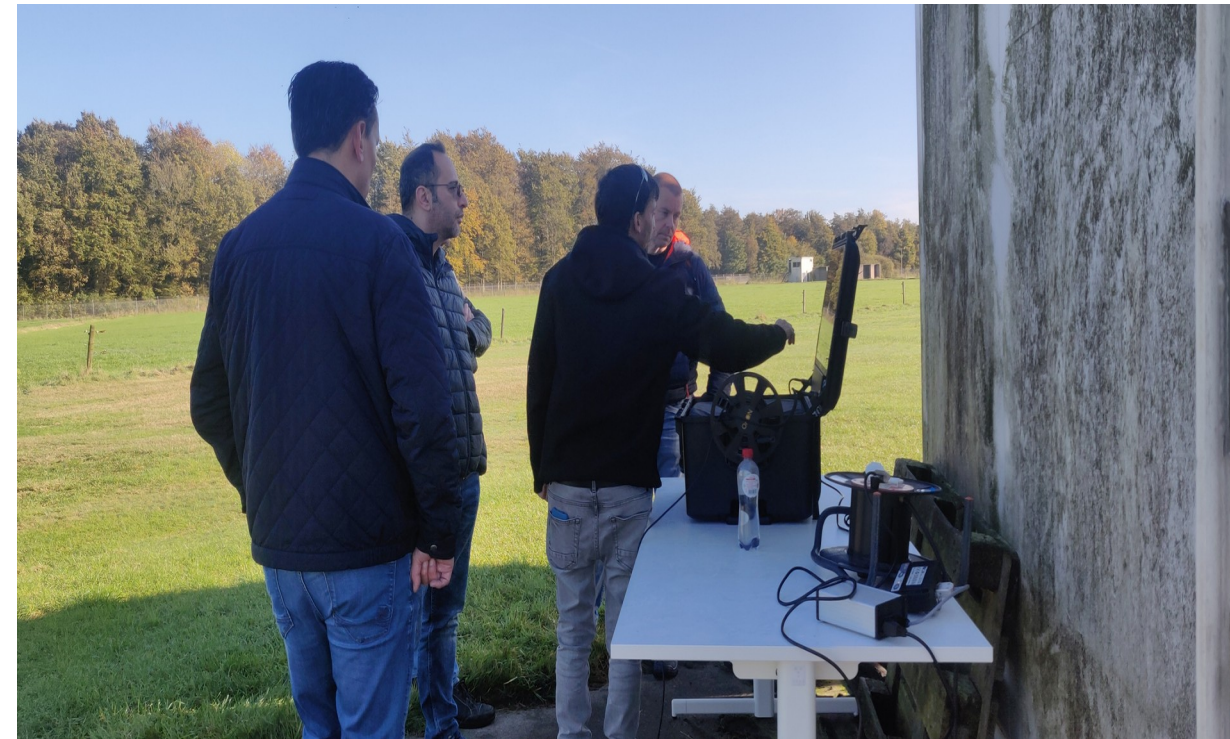
# FEASIBILITY TEST

- Collaboration between WyndTek, NLR – Royal Netherlands Aerospace Agency & DreNDT Industries through the World Class Maintenance, AIRTuB Project.

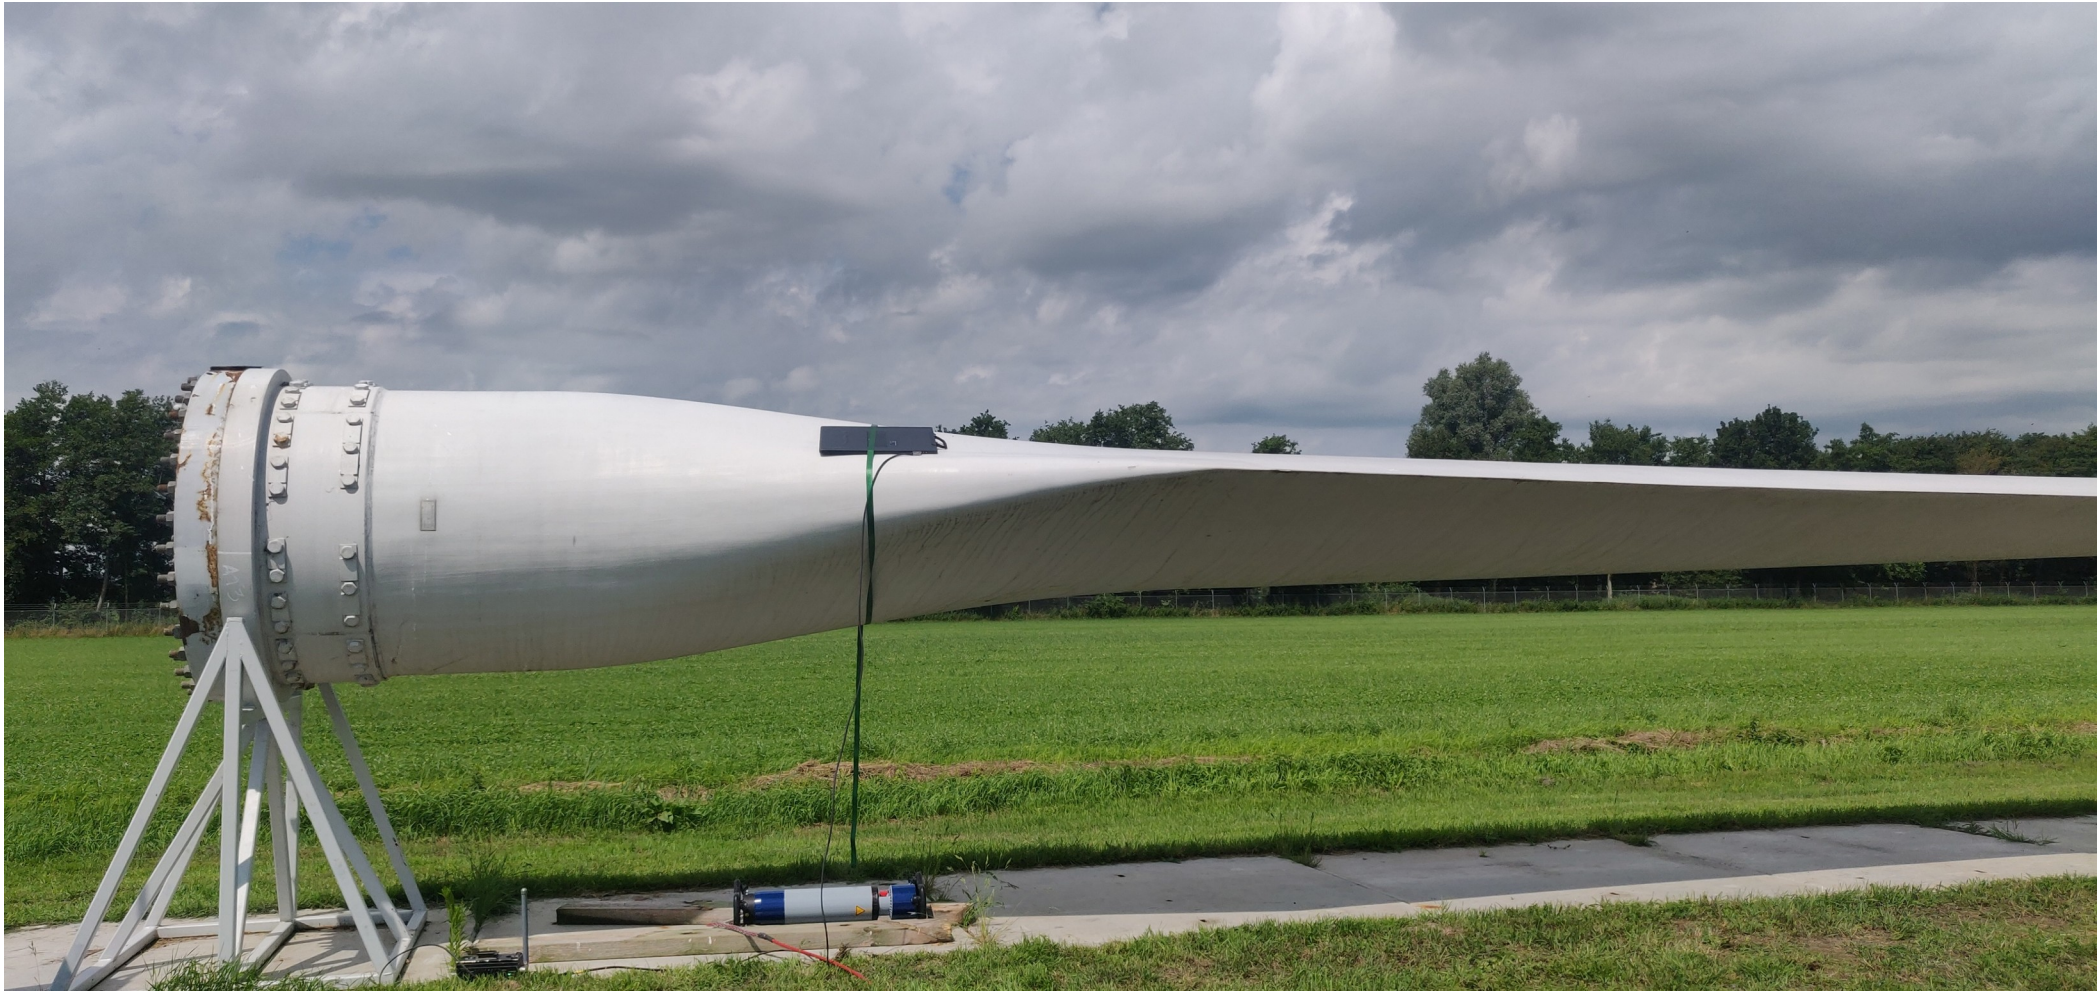
- A portable Digital Radiography system is capable of penetrating through the bulk of a 22m wind turbine blade made up of composite GFRP material.

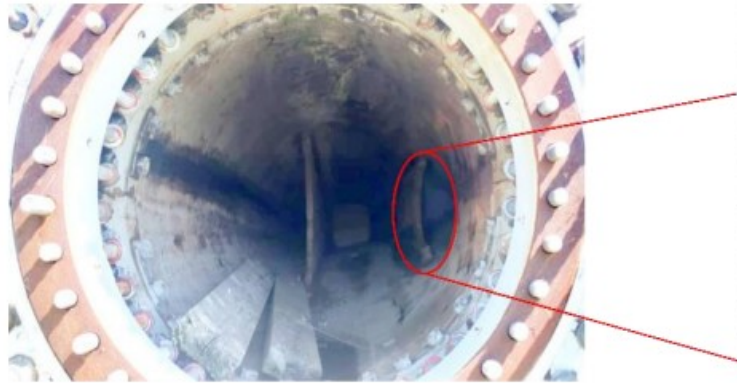
- Blind hole detected in the bulk of the left shear web structure
- The multidirectional layered fibre's stacked on top of each other seen in the radiographs
- The distance between the individual composite glass fiber layers can be computed
- Delamination defects can be possibly detected by scanning 360° around the bulk blade structure and stitching the 2D scans to make 3D radiograph models

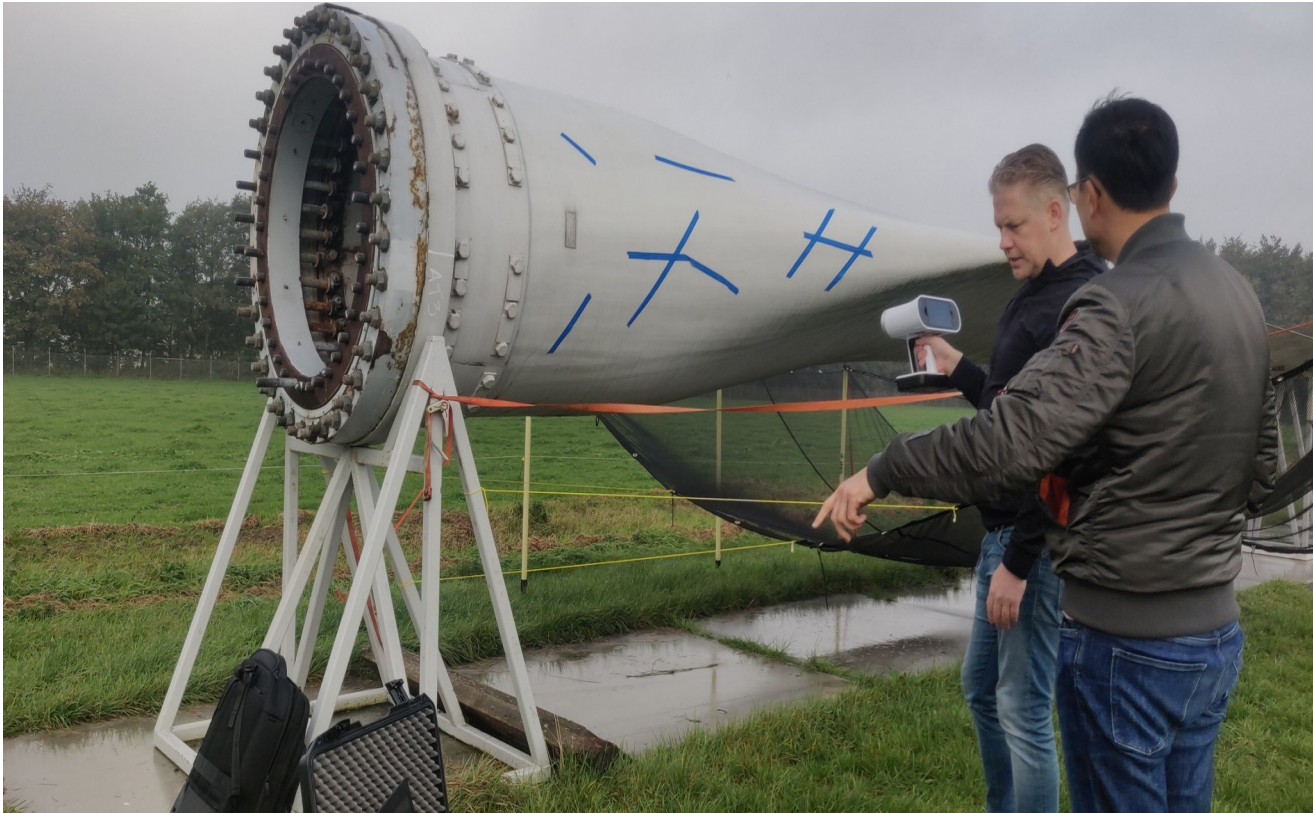
- LiDAR scanning of turbine blades for 3D reconstruction of scanned 2D radiographs.
