# C larucca

Al software and system company that develops structural health monitoring solutions for blades Hans van Beek – CEO Tarucca

AIRTuB Sensors for Damage Inspection of Wind Turbine Blades 12 April 2022

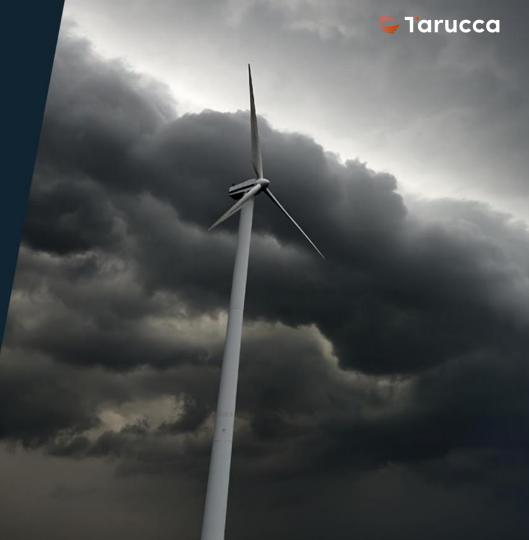
Electronic and Optical Accelerometers + Strain Gauges

Ice detection and load monitoring systems

Fiber Optic Sensing Cables

Shape monitoring and vibration measurement

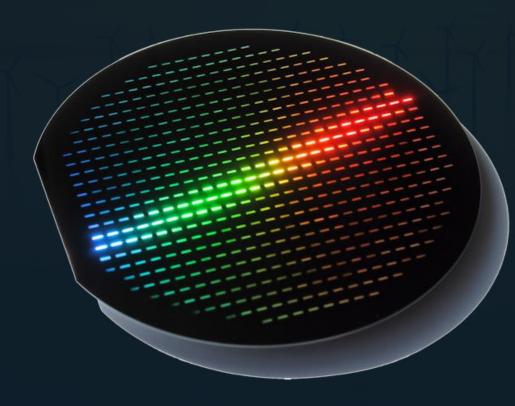
### New photonic chip based sensors perfect for blades

- Non-electric
- Lightning-strike safe
- Magnetic field insensitive
- 10x 100x more accurate than old optical technology
- Becoming available off-the-shelf
- Price levels sensors and
  interrogators rapidly coming down
- Allowing more than 2
  accelerometers per blade

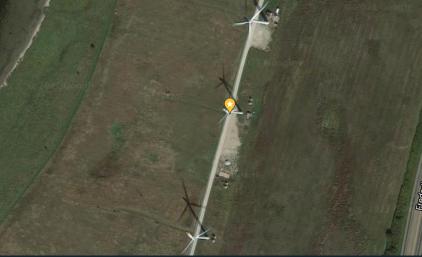
## **Confirmed Proof of Concept**

Tarucca SW project finalized in February 2022 confirmed:

- The feasibility of detecting different trailing edge crack sizes (15, 30, 45 cm) using 2 vibration sensors
- The feasibility of detecting these damages with sensors at locations in the blade where they can be easily retrofitted
- The feasibility of detecting these damages while the turbine is rotating, and the blade is actuated through the wind only.
- The feasibility of detecting these damages using data captured from an operating wind turbine.
