Automated Radiographic Testing (ART) for Corrosion Under Insulation (CUI)

Leon de Ridder – Business Development Manager A-NDT

TECHNOLOGY OVERVIEW

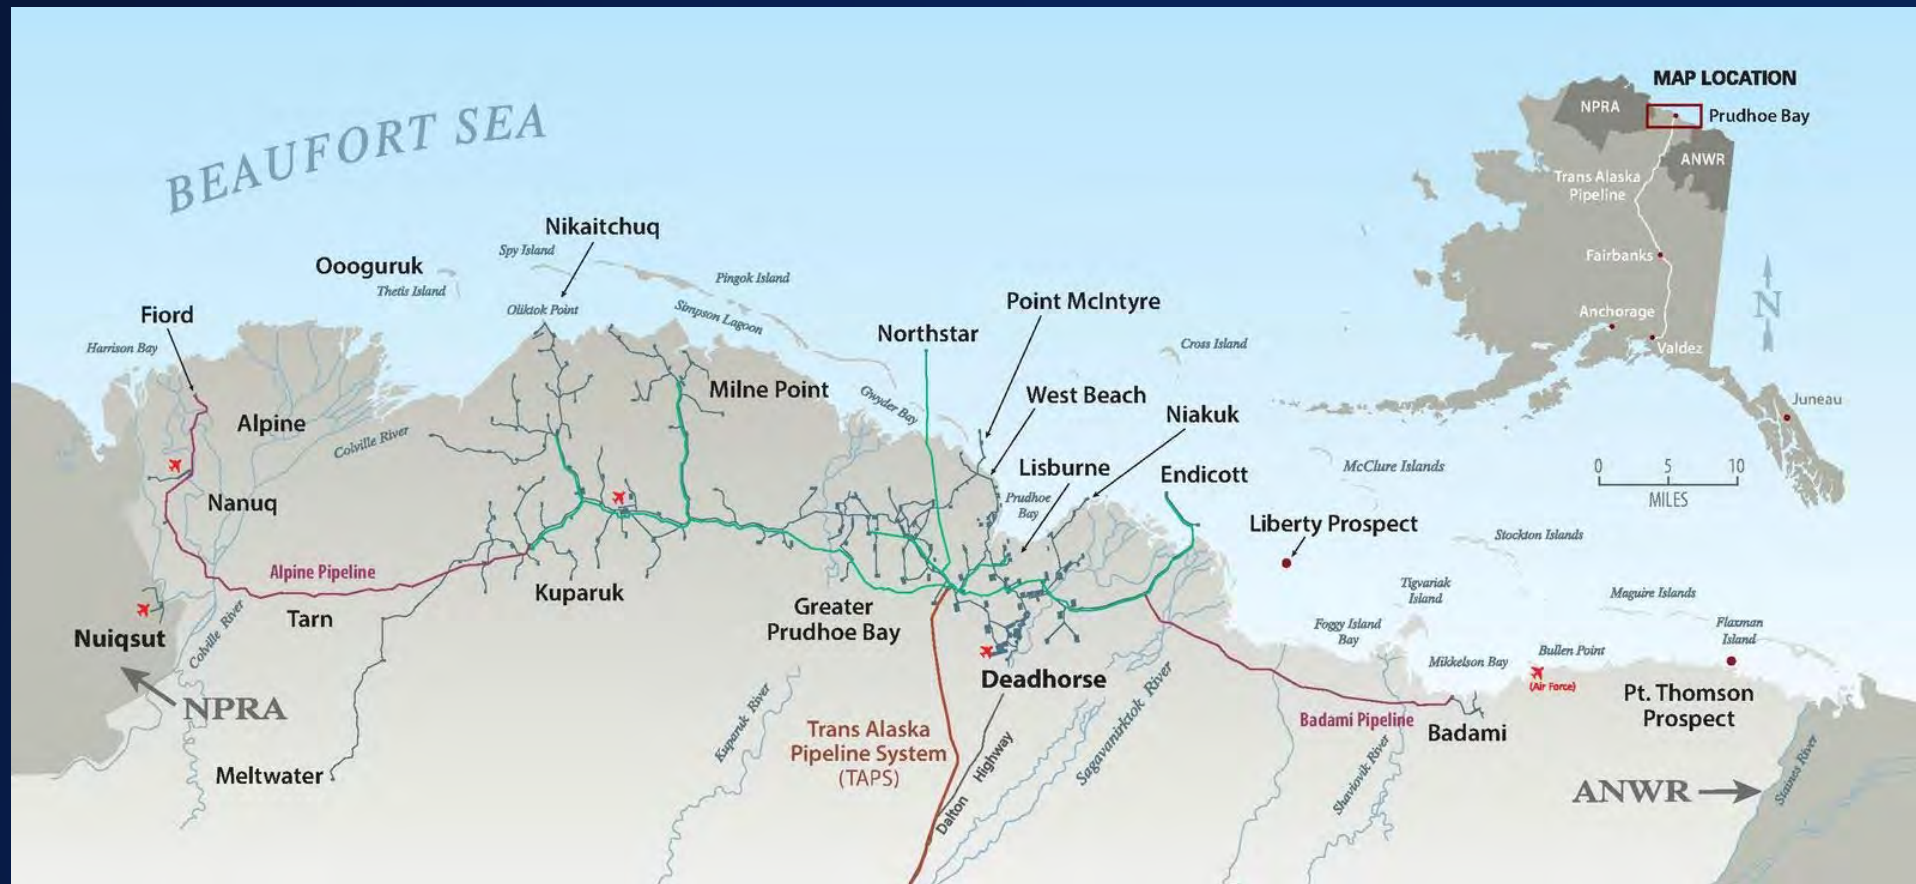
The North Slope of Alaska has over 20,000 kilometers of insulated above ground piping with a large percentage susceptible to CUI and internal corrosion.

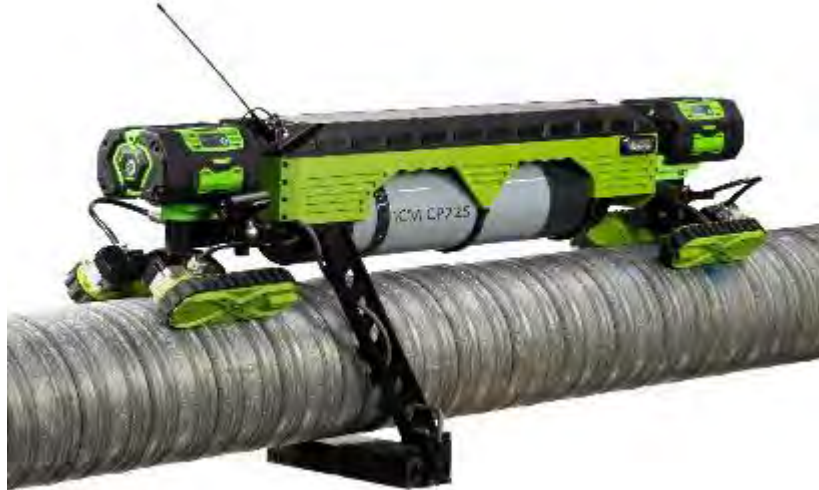
GENERATION 3

FUNCTION	Internal Corrosion
VIEWS	1
PIPE RANGE (INSULATED)	4"-48"
POWER	225 kV
COMMUNICATION	Wireless
MARKET	Up, Mid, Downstream
WEIGHT	70 lbs.
CLEARANCE	Robotic Arm: Top: 10"; Bottom: 2"; Side 1: 4"; Side 2: 0" Stationary Arm: Top: 10"; Bottom: 2"; Side 1: 2"; Side 2: 0"
DIMENSIONS	54.5" x 7" x 9.75"
EXPOSURE TECHNIQUE	Double Wall Single View (ID+OD)
TEMPERATURE RANGE (F)	-40 to 120
POWER REQUIREMENTS	56V Lithium Ion Battery

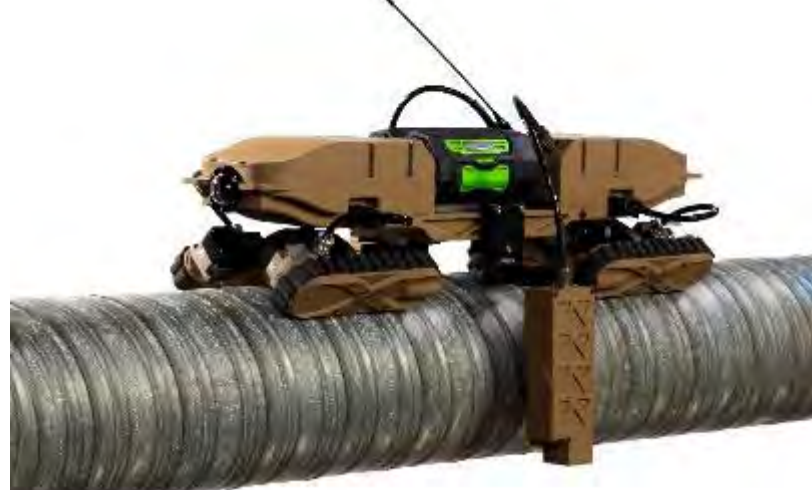
GENERATION 4

FUNCTION	Single View CUI (Bottom)
VIEWS	1
PIPE RANGE (INSULATED)	4"-48"
POWER	3 options, 70 kV, 120kV, 160kV (higher power for inspecting supports or saddles)
COMMUNICATION	Wireless
MARKET	Up, Mid, Downstream
WEIGHT	28 lbs.
CLEARANCE	Top: 7"; Bottom: 0"; Side 1: 1.75"; Side 2: 3.5"
DIMENSIONS	32" x 6" x 7"
EXPOSURE TECHNIQUE	Tangential (OD Only)
TEMPERATURE RANGE (F)	-40 to 120
POWER REQUIREMENTS	56V Lithium Ion Battery

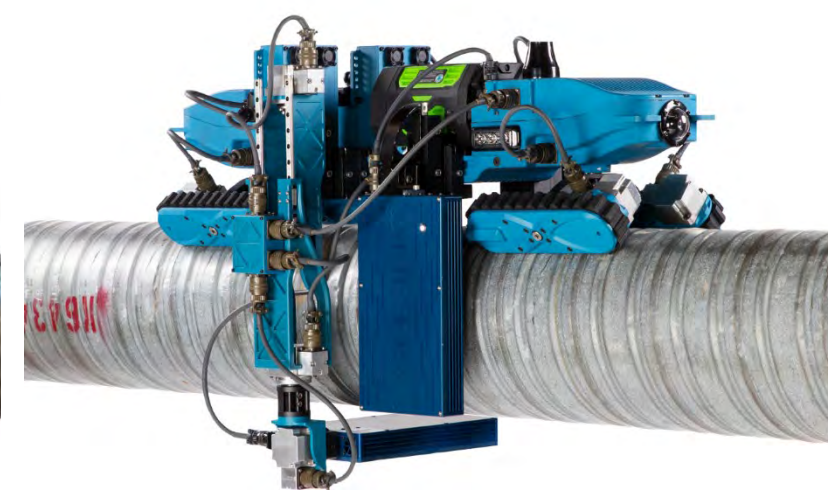
GENERATION 5

FUNCTION	4 View CUI (Bottom, Top, both sides)
VIEWS	4
PIPE RANGE (INSULATED)	2"-20"
POWER	70 kV
COMMUNICATION	Wireless
MARKET	Up, Mid, Downstream
WEIGHT	37 lbs.
CLEARANCE	Robotic Arm: Top: 8"; Bottom: 2"; Side 1: 4"; Side 2: 3.5" Stationary Arm: Top: 8; Bottom: 2"; Side 1: 2"; Side 2: 3.5"
DIMENSIONS	36" x 6" x 8"
EXPOSURE TECHNIQUE	Tangential (OD Only)
TEMPERATURE RANGE (F)	-40 to 120
POWER REQUIREMENTS	56V Lithium Ion Battery

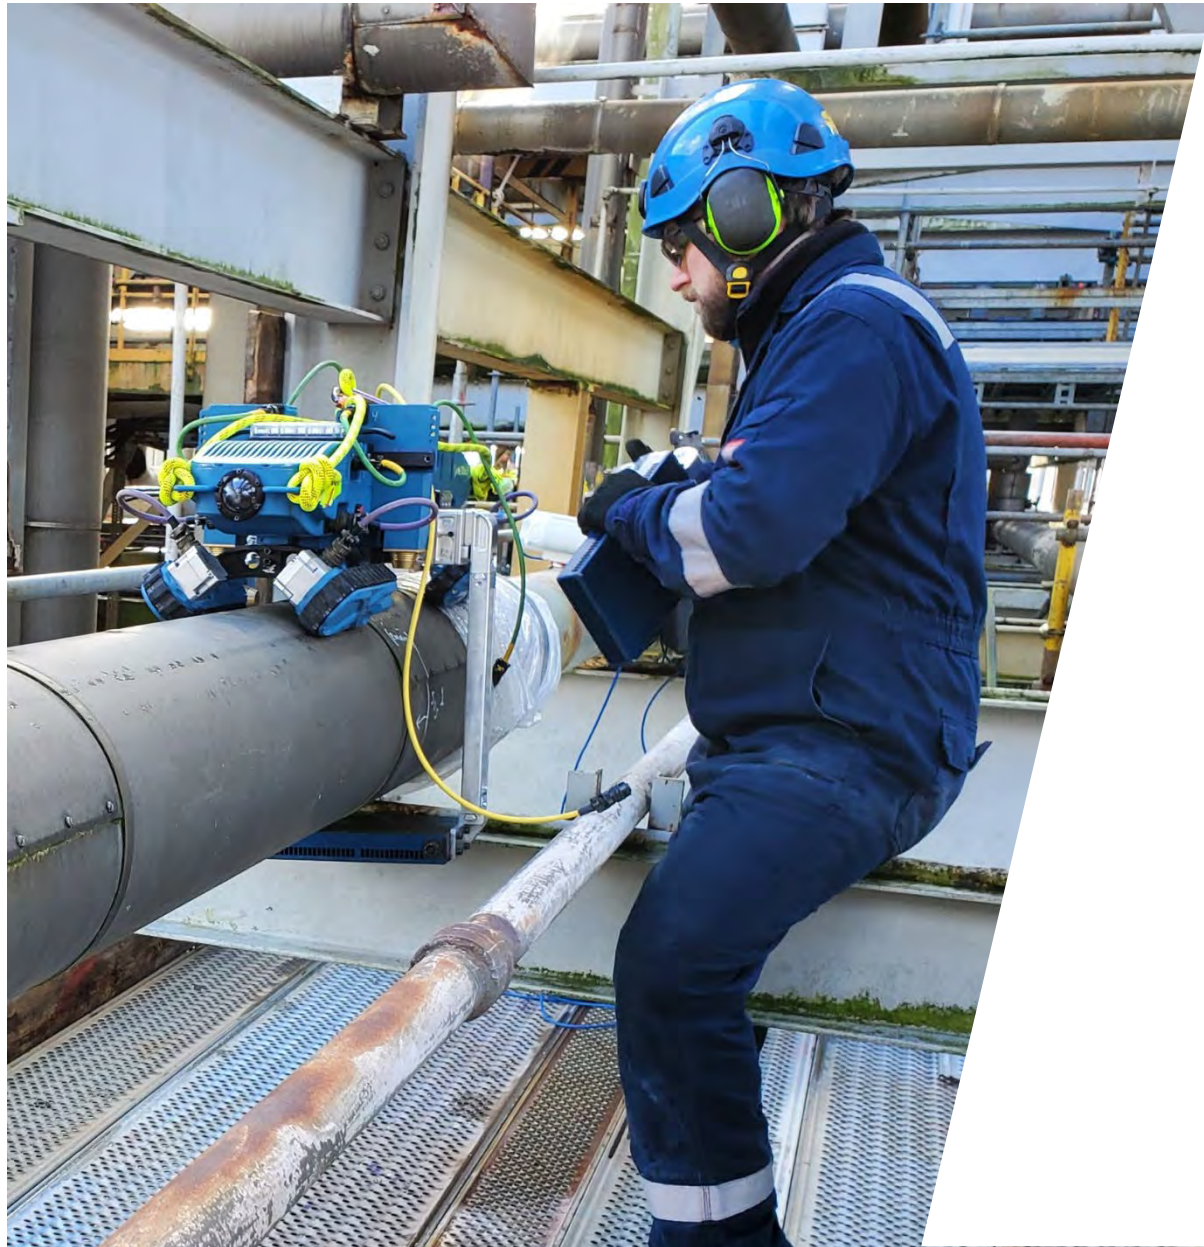
MISTRAS ART Crawler Generation 5

- ▶ 4 View CUI Inspection
- ▶ 4 x 70kV, 12W X-Ray Tubes
- ▶ 2 x 100 μ m Photon Counting Detector
- ▶ 37 lbs.
- ▶ Fully Wireless
- ▶ Weatherproof

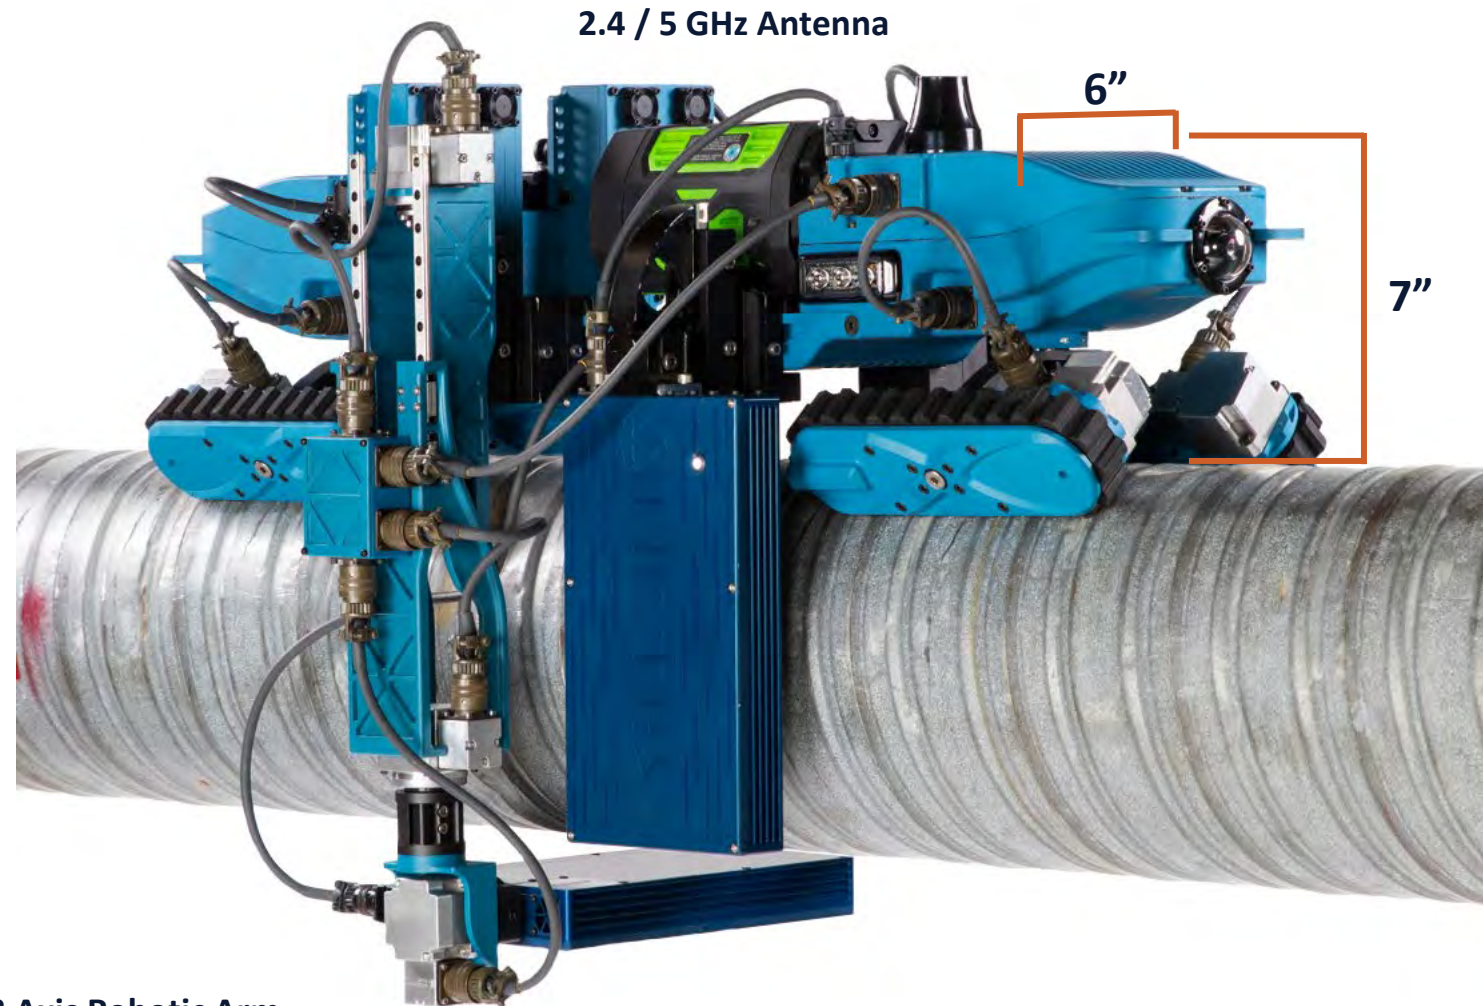
**3 Axis Robotic Arm
Enables Autonomous support traversal**

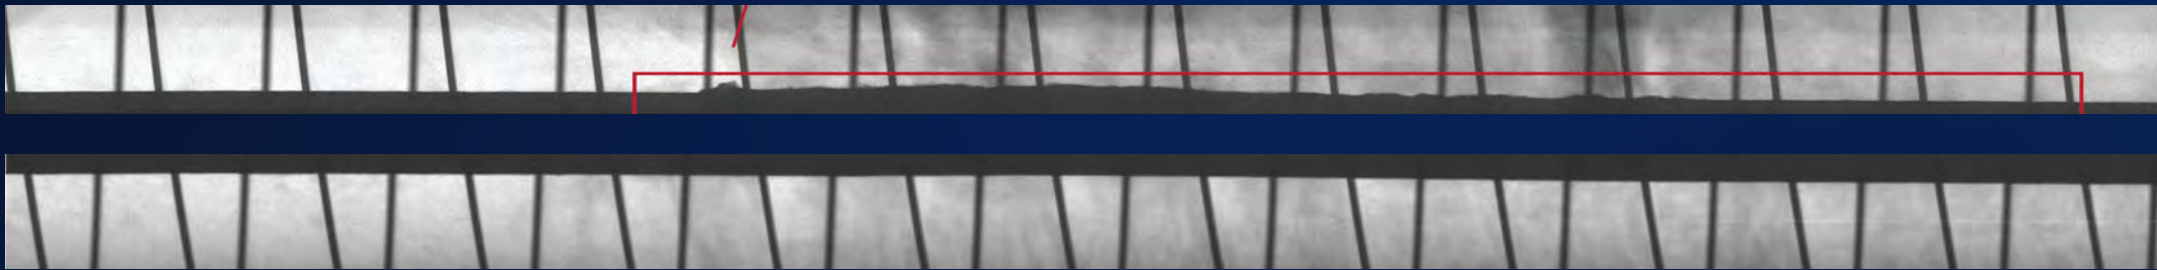
Radiographic map of the top and bottom of pipe

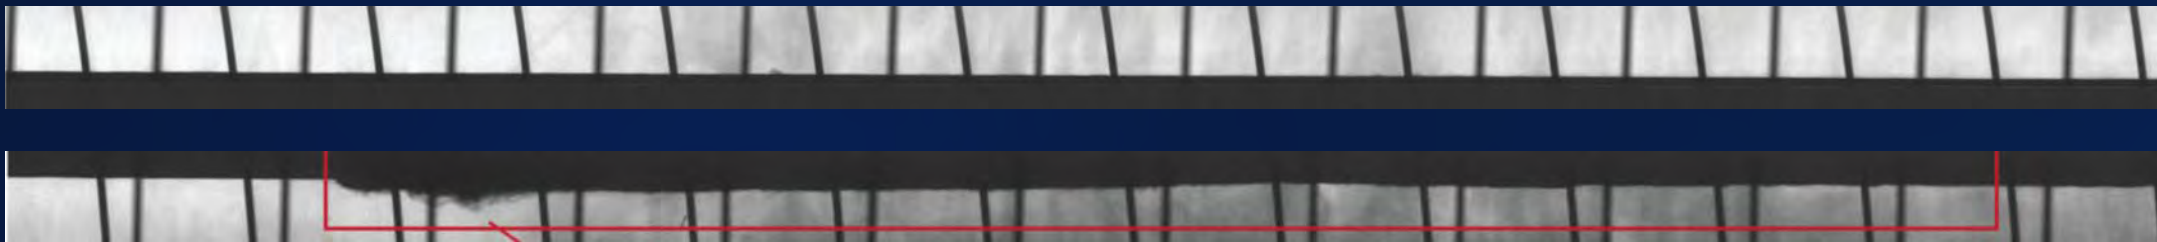
Radiographic map of both sides of the pipe

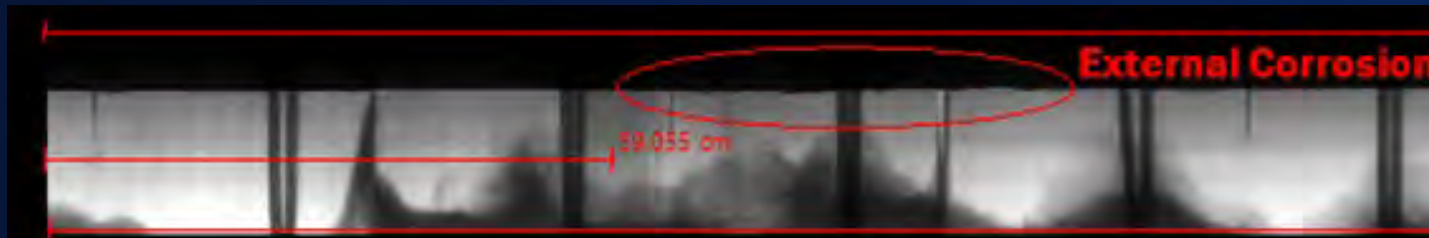
ART systems enable operators to determine the severity of external corrosion and moisture saturation by displaying the pipe wall to insulation interface.

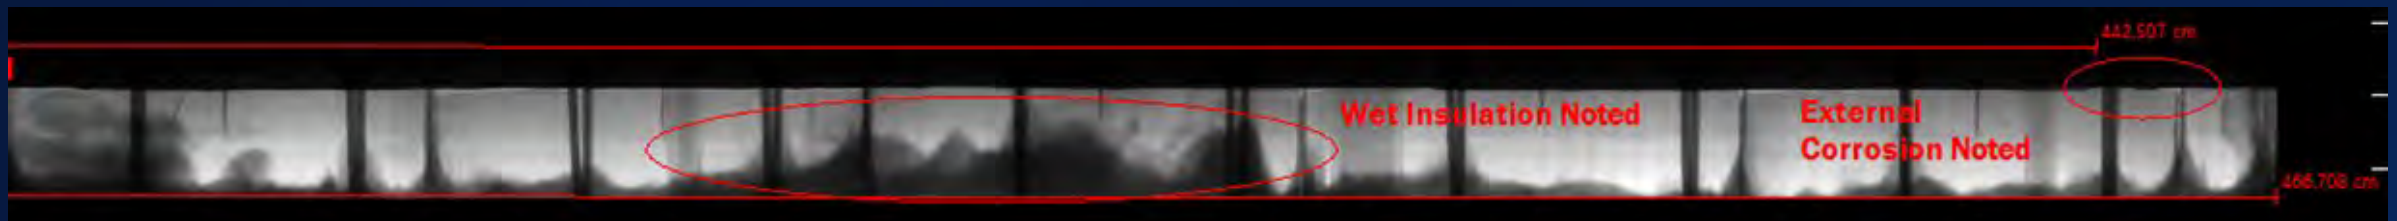
ART systems can also determine the start and stop locations of regions of interest through calibrated encoders and annotate distances and measurements directly on the radiographic map.

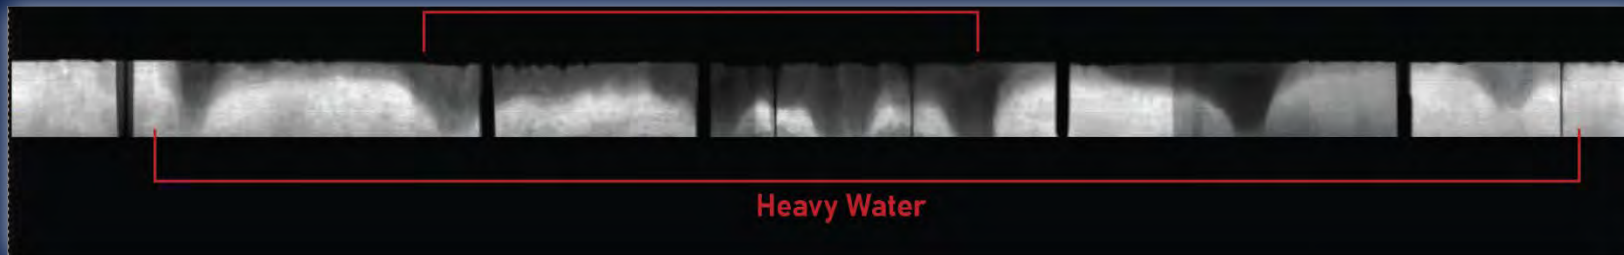
Live video capture and
DICONDE RT images save
for record retention and
analysis.

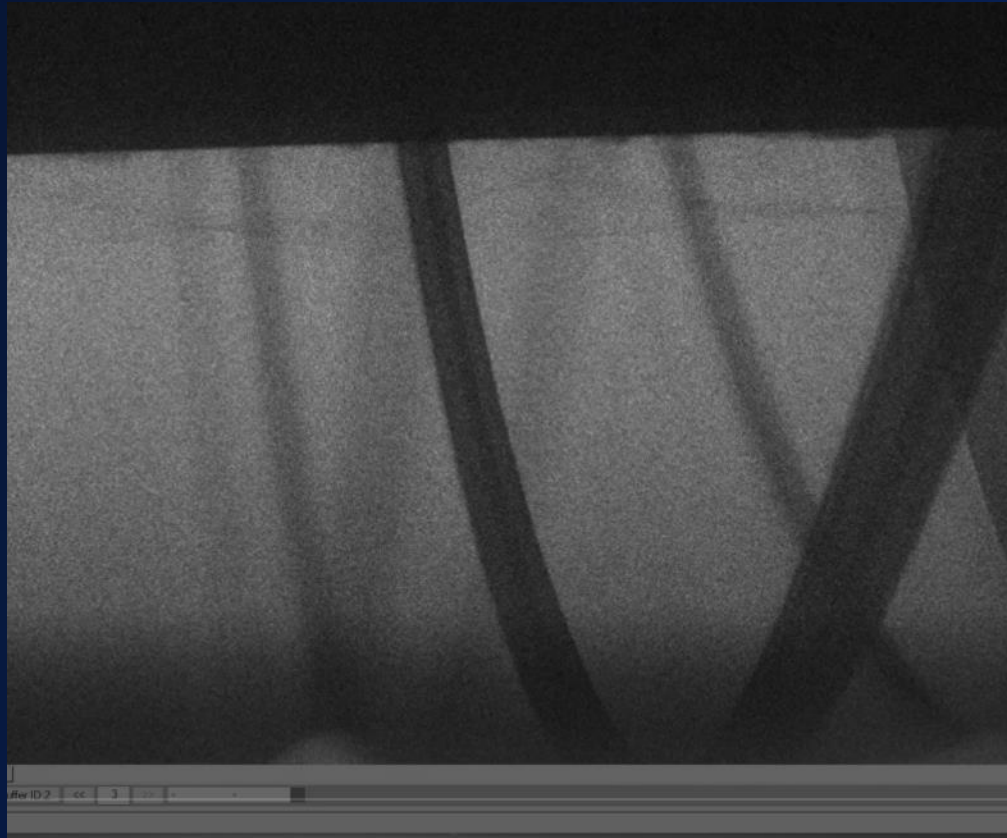
Scanner detected CUI indications and operator estimated wall loss range of 11%-17%

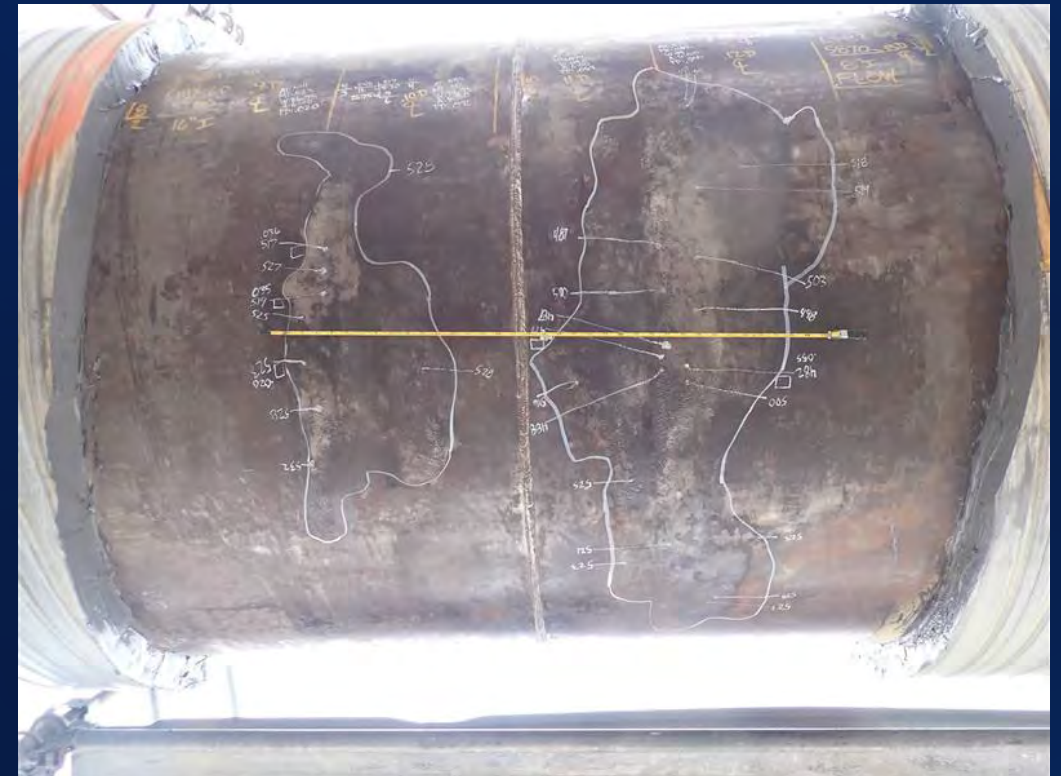
Strip and UT inspection confirmed wall loss of 12%
