TNO report

TNO 2020 R10402 | Final report

**Literature review of structural and non-
structural wind turbine blade damage**

| Project name | TKI HER AIRTuB - Automated Inspection and Repair of Turbine Blades |

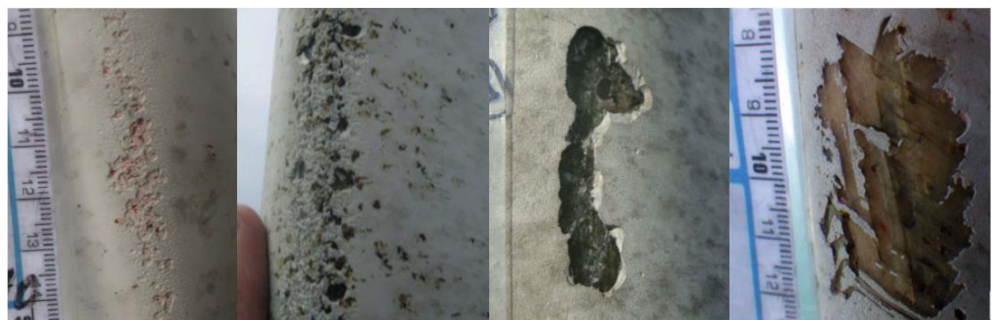
Figure 4 LEE life cycle. From left to right it can be seen a progression of LEE from a stage 1 up until a stage 5 category. Small pits overlap and become larger dents, which also overlap within each other until larger pieces of coating are removed. On the far right hand side

it is appreciated how an extreme case of LEE leads to a delamination, exposing the structural component to degradation.

Studies suggest the life cycle of LEE starts as minor chipping of the external coating, also referred as *pits*. These features are described as non-deep [0.1mm-0.3mm] and small [0.5mm-4mm]. After a high density of pits are formed in the surface, they tend to form close together and eventually merge into larger features known as voids. This features have irregular shapes, and are both larger [10mm-40mm] and deeper [0.3mm – 0.8mm] than pits (Gaudern, 2014), (Bak, 2020).
