Innovation Fieldlab Zephyros

*Towards Zero downtime and
Zero on-site maintenance*

AIRTuB Problem definition

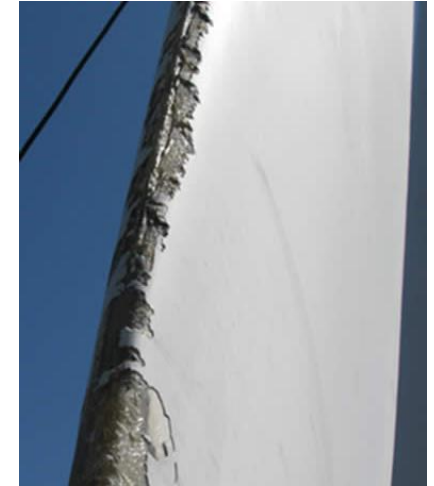
Blade damage (leading edge and structural) leads to:

- (Manual) inspections
- Vessel movements
- Aerodynamic losses, lower AEP
- Expensive repairs
- Reduced up-time

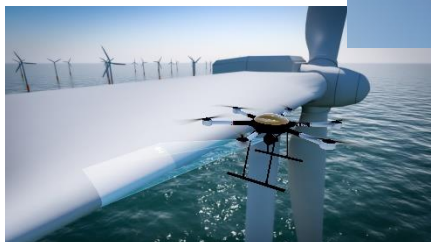
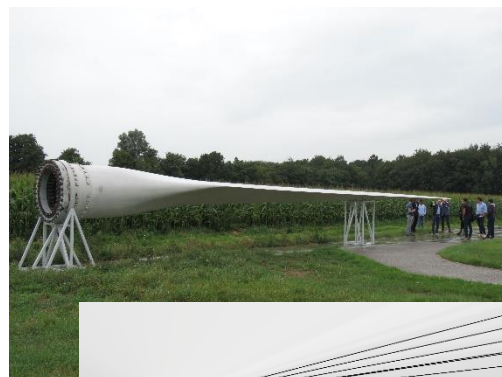
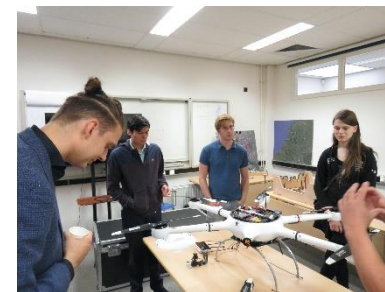
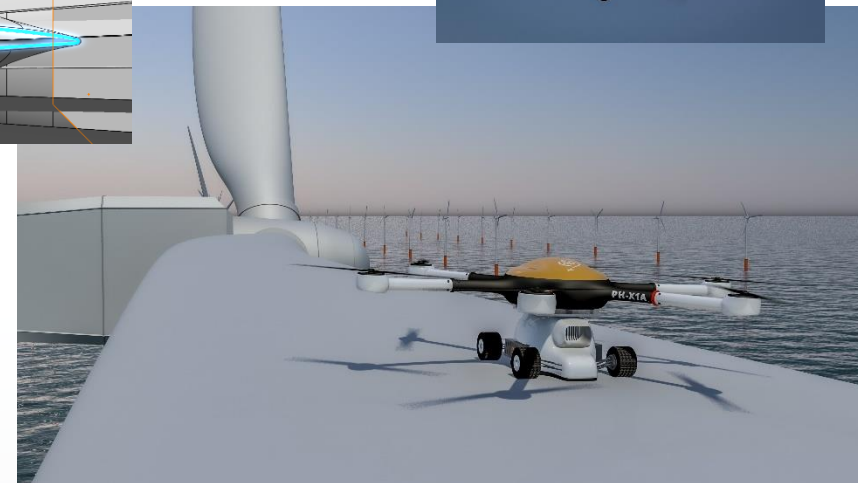
Artist impression pictures courtesy of NLR®

Goal:

- Drone and Crawler development
 - Bringing sensor packages to the blade
 - 3D visual inspection or laser line scan
 - Structural damage inspection (crawler!)

Developments:

- Existing drone adaptation
 - Reliability, robustness,
 - Safety; a.o. parachute & floating device
- Flight controller for wind gusts
- Path planning: lidar sensor
 - Keeping track of leading edge/turbine blade
- Crawler development for structural damage inspection sensor
- Test & demonstration indoor/outdoor; onshore & offshore demo

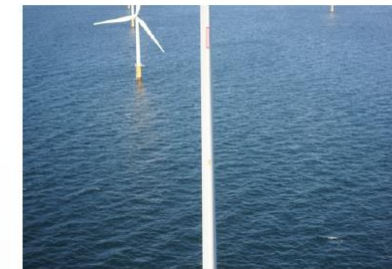
Princess Amalia - WPQ7-30 | Erosion - Severity 2

Turbine Information	
Manufacturer	Vestas
Model	V80
Latitude	52.5817552264286
Longitude	4.24583791257143
Hub Height	
Rotor Diameter	
Blade A Serial	51216 (Unconfirmed)
Blade B Serial	51462 (Unconfirmed)
Blade C Serial	51387 (Unconfirmed)
